Centre field: A case for visualising the fabric of the New Zealand historic garden

John P. Adam¹

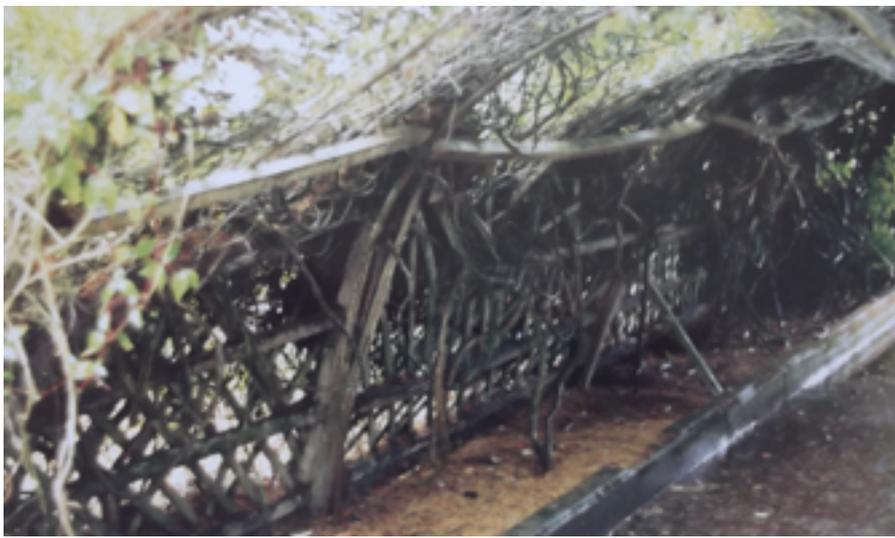
Fig. 1 Rustic wooden arbour from Larnach Castle grounds, Otago. 1983. Photo: John Adam.

To return to the *Heritage New Zealand* article, Beresford (2010, p. 19) quoted the owner of Otago Peninsula's Larnach Castle, who stated that "Larnach was not a gardener..." to seemingly justify not conserving any of the garden elements Larnach oversaw the construction of, including an amazing rustic arbour that stood in the grounds until the early 1980s (Fig. 1).

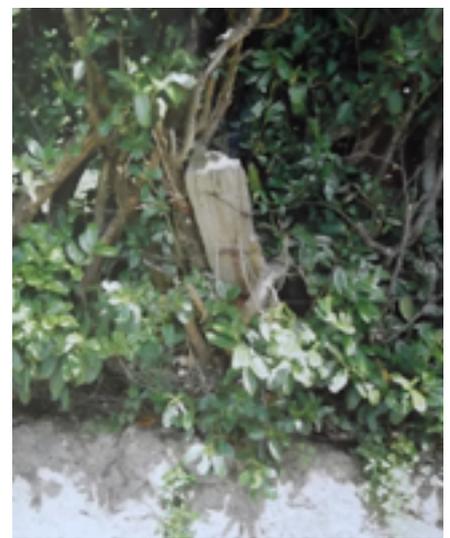
Fig. 2 Live hedge on earth bank with wire fence and imbedded timber posts, Masterton. 2010. Photo: John Adam.

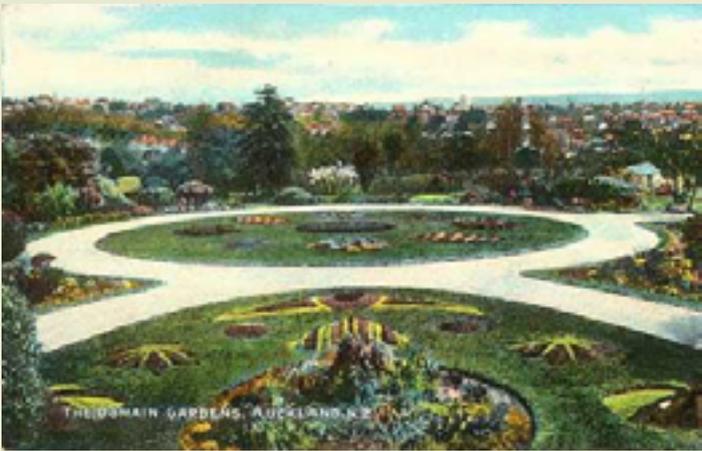
Fig. 3 Carpet bedding scheme in Auckland Domain. Source: Postcard, c. 1905.

- Flower garden – Albert Park 'parterre' with stone mulch (Salmond Reed Architects et al., 1997). Carpet bedding (Fig. 3), raised gardens.
- Market gardens – (Chinese, Māori) – fields, irrigation, dwellings and infrastructure.

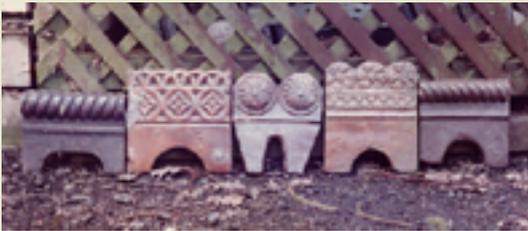
Fig. 5 Terracotta garden edging tiles discovered about Auckland central city in the 1980s. Photo: John Adam.

- Terracotta edging tiles (Fig. 5), bricks, bottles, timber, concrete posts (Fig. 6; as seen in ground of Westoe, Manawatu, 1980s), painted (blue/white) timber pegs, paua shell Mount Roskill gardens 2012.

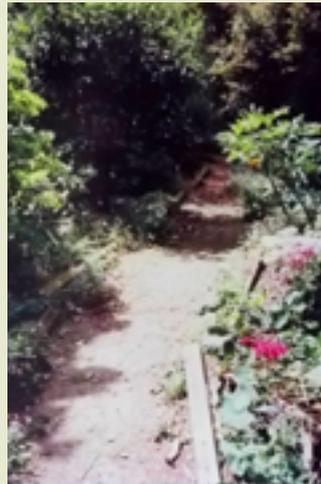
Fig. 6 Concrete fence posts used as a garden border at Westoe. 1980s. Photo: John Adam.

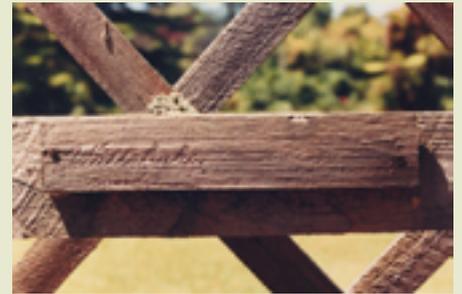
Fig. 7 Wooden plant label of a New Zealand bred rose cultivar. Government Gardens, Rotorua. c. 1985. Photo: John Adam.

- Tree and plant identification labels – timber (Fig. 7), ceramic, iron, and plastic associated with experimental and systematic gardens.
- Rockeries and rock gardens – created on Government Domains at Te Aroha, Rotorua (Fig. 8), and Queenstown by T. E. Pearson and Palmerston North Square (demolished early 2000s).

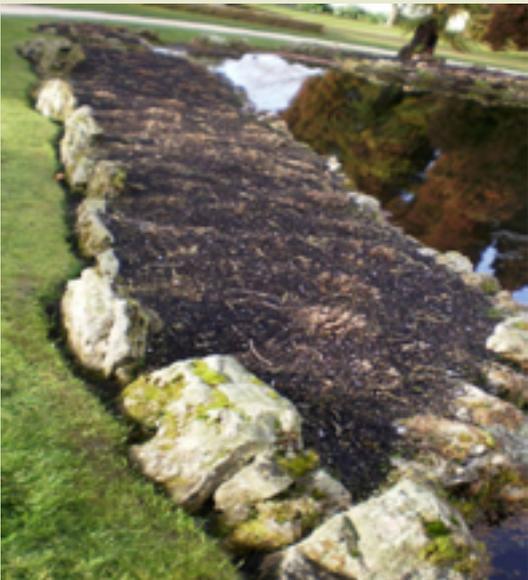
Fig. 8 Local rock contained rockery gardens alongside stone enclosed 'lakelet' in the Government Gardens Rotorua. 2011. Photo: John Adam.

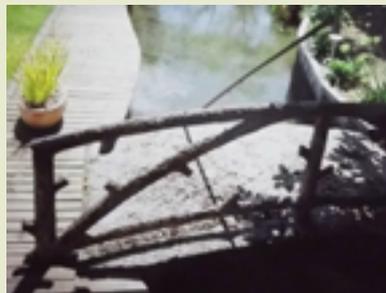
Fig. 9 Rustic timber and concrete bridge in a Masterton garden. 2010. Photo: John Adam.

- Cairns – concrete, stone, and timber.
- Ditch and turf bank with live hedges, posts and rails.
- Hedges – various species (e.g., *Rosa* spp., hawthorn).
- Balustrades – concrete, plaster, stone, and timber (Fig. 9).
- Concrete modernist low nib wall structures (e.g., Hayes Paddock, Hamilton; Mt Eden and Mount Roskill, Auckland), prefabricated/ cast concrete c. late 1930s.
- Trellis ('Rima', 1947).

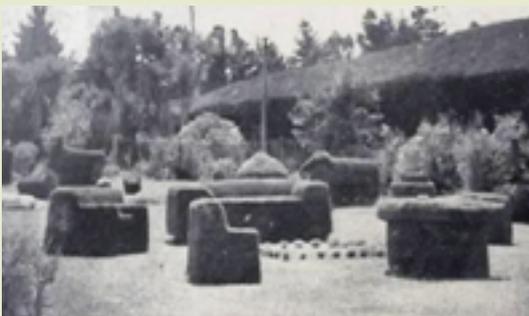
Fig. 10 Macrocarpa plants shaped and trimmed into living furniture in a Pahiatua garden. Source: *The Garden*. AWN, 6 August, 1947, p. 38.

- Commemorative single or mass plantings, sacred groves, arboreta.
- Shelter trees, to protect buildings from wind and snow (e.g., the Otago blizzard of 1863); landscape elevation for maximum effects (1880s – quoted by Truby King for Hamilton planting scheme).
- Tree guard enclosures, timber constructed to exclude grazing stock (e.g., Auckland City and Provincial towns 1870s through 1880s).
- Arbor Day plantings – school grounds, urban parks and street trees – later between WWI and WWII (e.g., Auckland suburbs of Epsom).
- Abandoned pollarded trees; clipped live hedge garden furniture (Fig. 10), topiary animals.
- Bush house and native shrubbery ('Rima', 1947), bush gardens (Strongman, 1984).

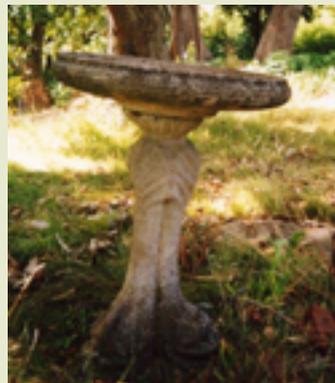
Fig. 11 Ornamental bird bath from Woodville Gardens, Auckland. 2006. Photo: John Adam.

- Lakelets – T. E. Pearson's designed features at Auckland, Rotorua, Christchurch and Queenstown Domain.
- Ponds (for fish and enclosing 'rabbit breeding islands'⁴), water races, dams; Japanese style and modern functional biomorphic form.
- Concrete birdbaths (Fig. 11) and fountains (Fig. 12).

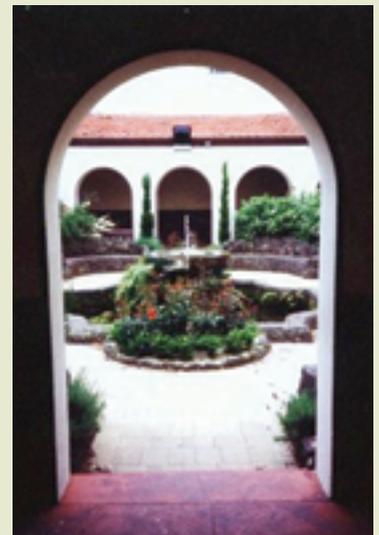
Fig. 12 Spanish style garden court with a 19th century fountain reused from the demolished Rotorua Town Hall. c. 1997. Photo: John Adam.
