## Restoration planting organised by Naturally Native for the Tauranga District Council, especially the Matua Saltmarsh stormwater ponds

### ABSTRACT

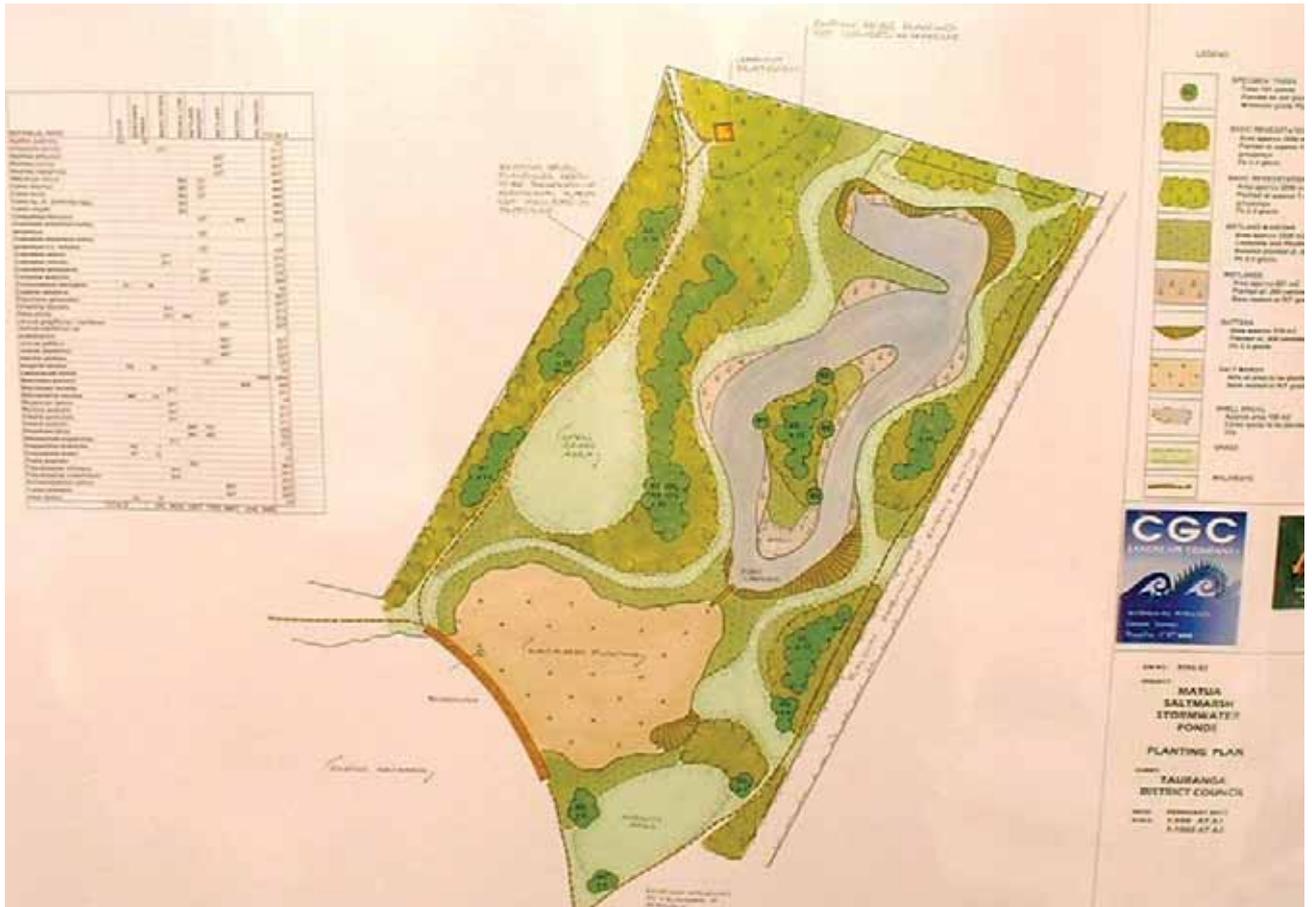
**Fig. 1** Planting plan for the Matua stormwater retention ponds.

In October 2001, the Tauranga District Council approached Naturally Native to organise the supply of plants and project management of a planting programme for the development of the Matua stormwater retention ponds. The Tauranga office of the Isthmus Group prepared the initial concept. The planting plan was developed by Naturally Native with input from local residents and the Tauranga branch of Forest and Bird (Fig. 1). The plan involved wetland planting and general revegetation, including some larger tree species. CGC Landscapes were contracted to undertake the actual planting work.

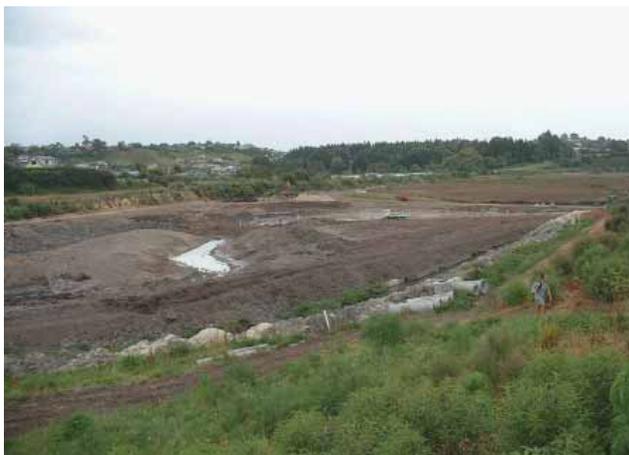
**Fig. 2** The 2-ha Matua saltmarsh site before restoration planting.

The Matua saltmarsh site (Fig. 2) is approximately 2 ha in area, and before restoration planting the site was largely covered in rank grass and blackberry, with a wet central drain. The concept was to build two stormwater buffer ponds, between the street run-offs and the Matua saltmarsh. The upper pond would be fresh water and the lower pond would be tidal. The two ponds

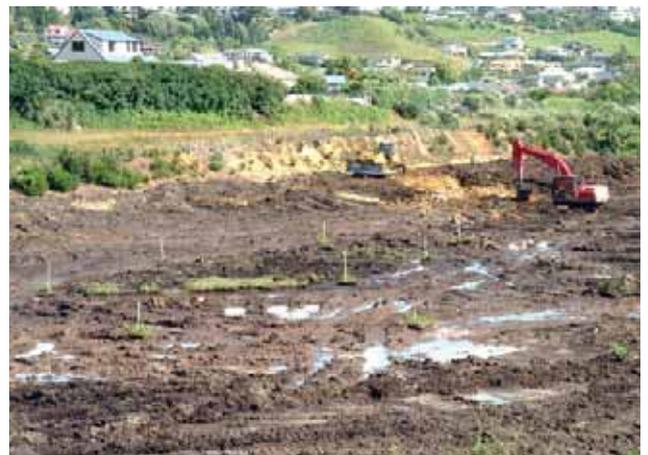
**Fig. 3** Earthworks on the Matua saltmarsh site in January 2002.

The earthworks contractors started work late in December 2001. They were plagued by wet weather throughout January (Fig. 3) and February 2002 — the summer season was one of the wettest the Bay of Plenty had experienced for many years. Not only did this result in the completion of the earthworks being delayed, but there were also problems with planting. Wet soils made access difficult and the planting contractors were not able to get onto the site until late in April, when the ground had dried out sufficiently to enable mulch to be spread. Because of the wet, boggy site, it was decided to spread mulch first and then to plant through it. A combination of recycled wood chip (which proved to be very effective; Fig. 4A) and post peelings (Fig. 4B) were used as mulch.

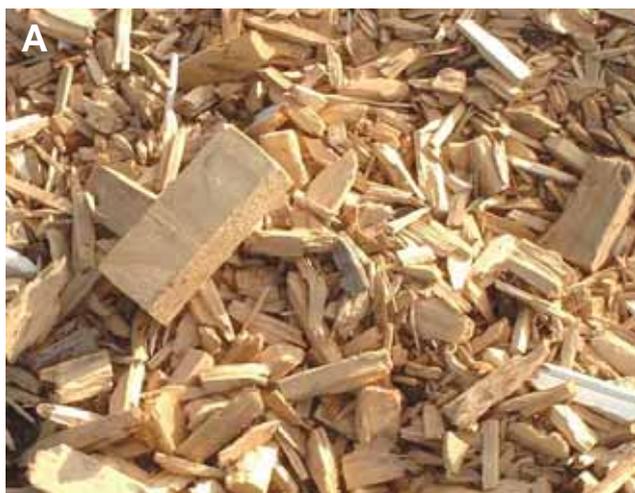
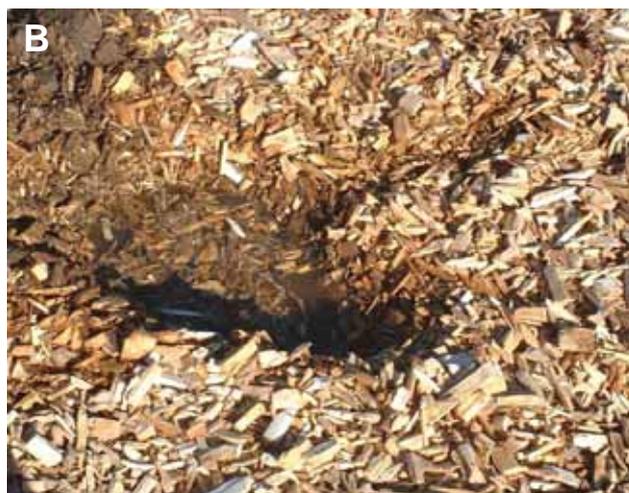
**Fig. 4** Detail of mulch used for Matua restoration plantings. **A**, recycled wood chip; **B**, post peelings.

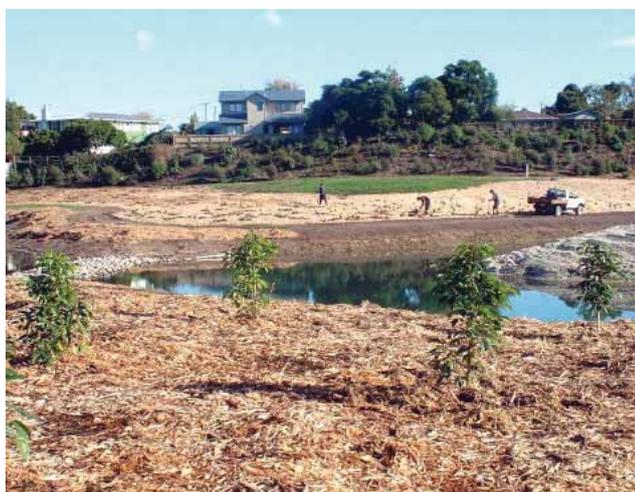
**Fig. 5** CGC Landscapes planting revegetation and tree species on a drier site during May 2002.

The CGC Landscapes team undertook placement and planting of the plants, both on the drier sites (Fig. 5) and in the wetland (Fig. 6). In the centre of the upper pond an island had been created as a bird refuge with an open sandy bird roost at one end. The sand and mulch were moved onto the island and spread before the pond was flooded. However, at the time of planting the pond was already filling, so the plants had to be ferried across by boat (Fig. 7).

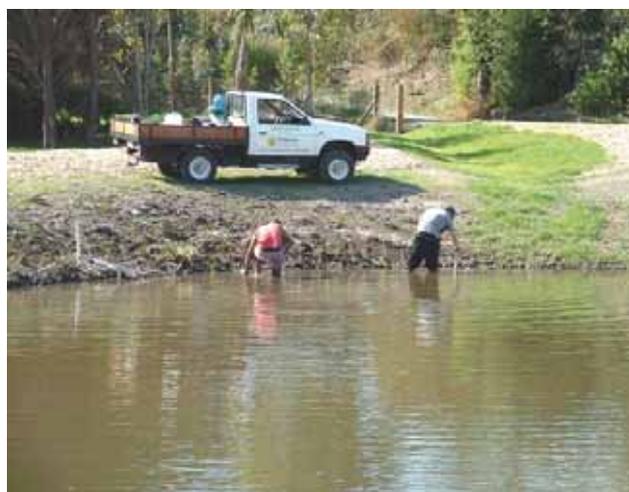
**Fig. 6** CGC Landscapes planting wetland species.

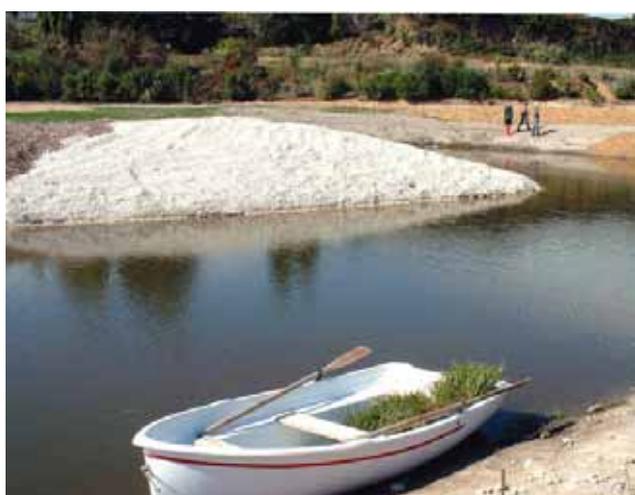
**Fig. 7** Plants ferried to island by boat for restoration planting.

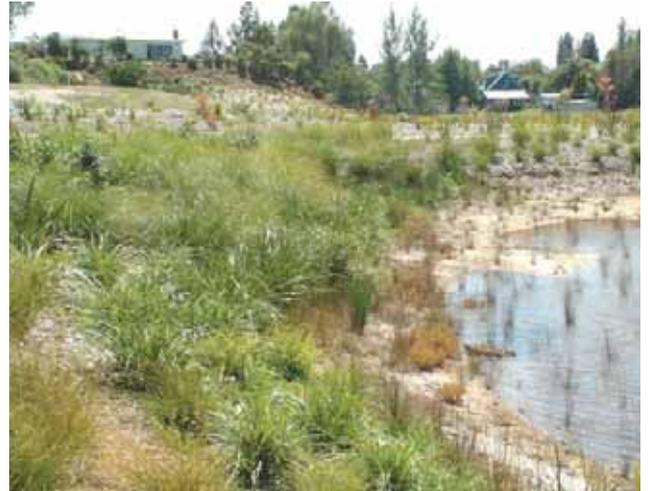
**Fig. 10** Lower pond margin (at high tide) six months after planting. Photo taken December 2003.

Some six months after planting there were obvious signs of growth (Fig. 10). The grass

species were establishing, and oioi (*Apodasmia similis*) was just coming through.

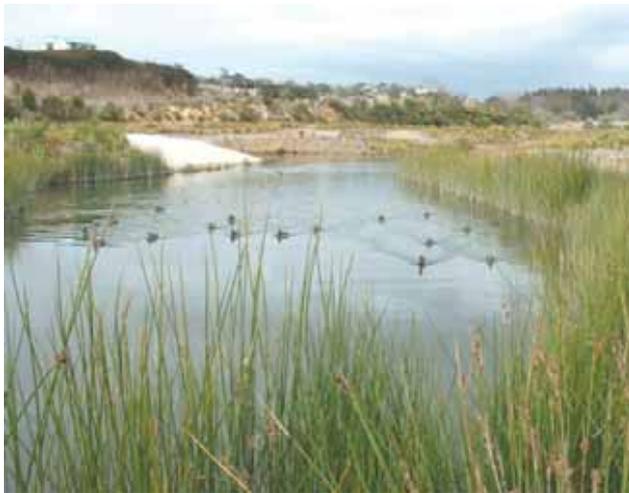
**Fig. 11** One year after planting. Photo taken July 2003.

A year after planting the results speak for themselves (Fig. 11). The planting has been a considerable success with well-established reed species around the pond edges, and waterfowl frequenting the ponds. However, the general revegetation species in this area will need some attention in the coming year. This includes application of fertiliser, as the plants here have not grown as quickly as expected, possibly due to the poor soil conditions on the extensively disturbed site.

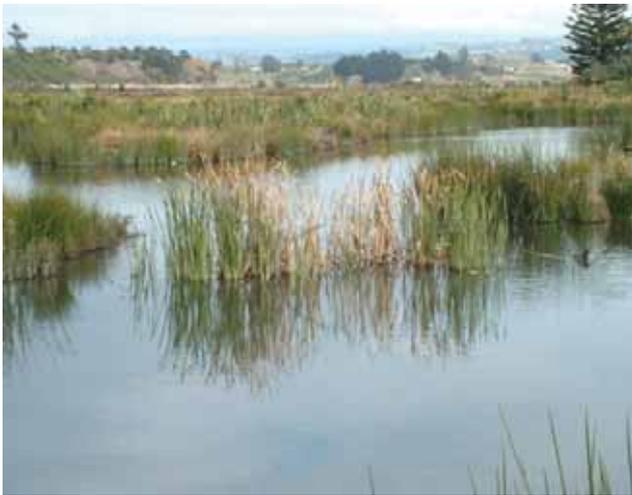
Fig. 17 Raupō (*Typha orientalis*).

Raupō (*Typha orientalis*) was not planted but has established spontaneously (Fig. 17). Unfortunately, this may prove to be a problem for the future managers of these stormwater ponds. As the ponds are not very deep, raupō may eventually infest the whole area if left. We would recommend its removal from this site, as the ponds are not of sufficient depth to limit its growth. This species should not be planted in water less than 2 m deep.

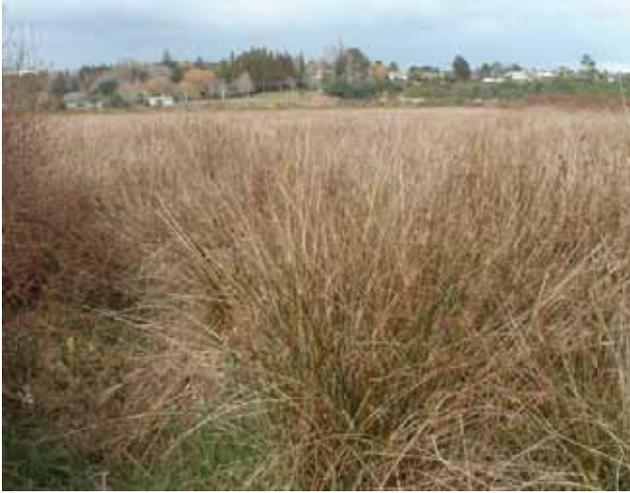
**Fig. 21** *Juncus kraussii* growing naturally adjacent to the ponds and plantings. This species is expected to establish by itself into the Matua restoration area.

For example, *Juncus kraussii* was not included in the planting plan for the Matua site. As this species naturally occurs adjacent to the ponds and plantings, just across the walkway (Fig. 21), we felt that there was no need to plant it in the lower saline tidal pond area because it is going to quickly establish itself there anyway.

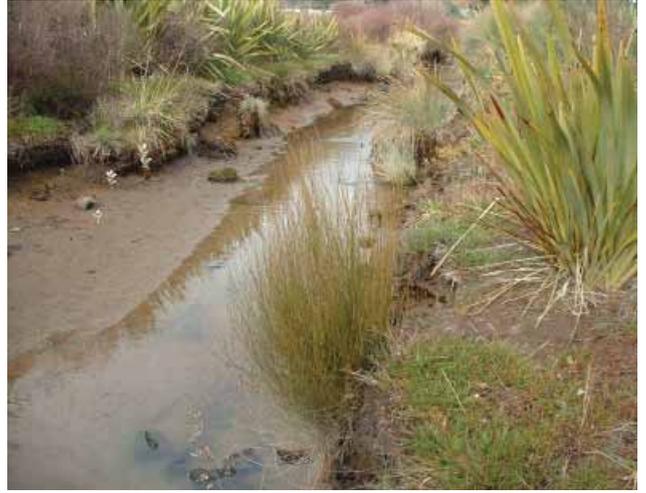
**Fig. 22** Saltmarsh ribbonwood (*Plagianthus divaricatus*), oioi (*Apodasmia similis*), and flax (*Phormium* spp.) growing in an area adjacent to the Matua restoration plantings.

Fig. 22 illustrates some of the plants that occur at the site in an adjacent area; saltmarsh ribbonwood (*Plagianthus divaricatus*), oioi (*Apodasmia similis*), and flax (*Phormium* spp.). Admittedly the flax has been planted here, but these species are going to disperse and some have already. *Cotula coronopifolia* had established itself in the lower tidal pond (Fig. 23). Opposite the ponds, in the saltmarsh there are large patches of oioi amongst the *Juncus* (Fig. 24). These patches will establish in the revegetation area over time, by themselves — no effort is necessary to recreate it, just a little patience.

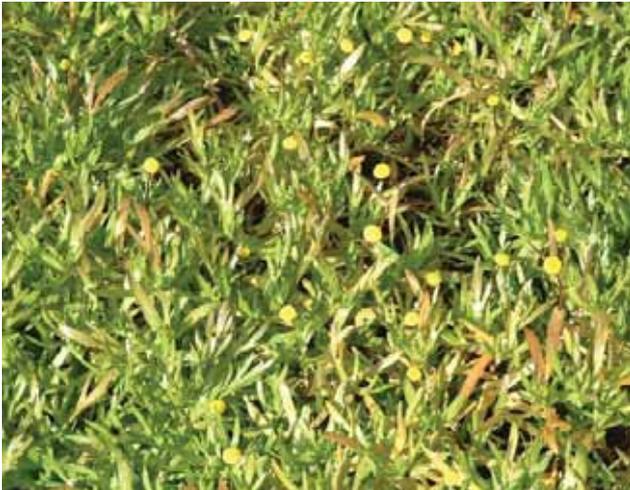
**Fig. 23** *Cotula coronopifolia* that has established itself in the lower tidal pond.

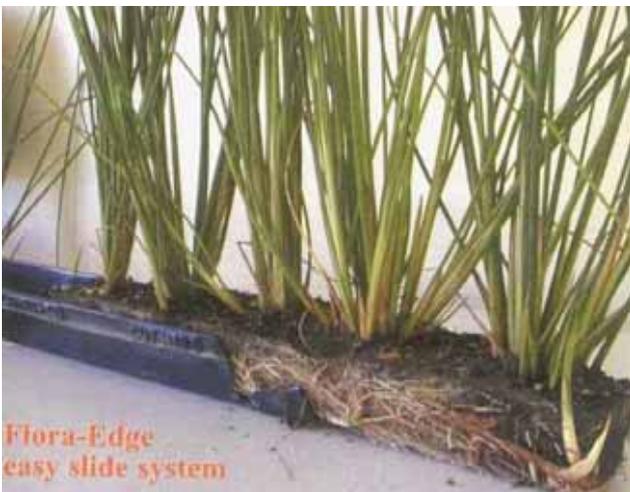
**Fig. 25** Plants growing along a trough in 'wetland strips'.

One of the major lessons learned from this project was that most of the wetland plants, given the right conditions, are easy to establish. However, we need to adopt new methods to overcome some of the problems that are encountered. One new approach we are trialing is the use of a product imported from Australia called 'wetland strips' (Fig. 25). With this system, a number of plants are grown along a trough until they are ready to be planted out. As the trough does not offer very much space, the plant roots become matted together. Initially the idea was developed as an edging concept for garden centres, but the system was found to be ideal for wetland plants as a whole strip of five plants cannot be pulled out by the birds.
